Structure Failures: Retaining Walls

Author: Timothy A. Roda, PE, StS2 – Project Engineer, Bracken Engineering

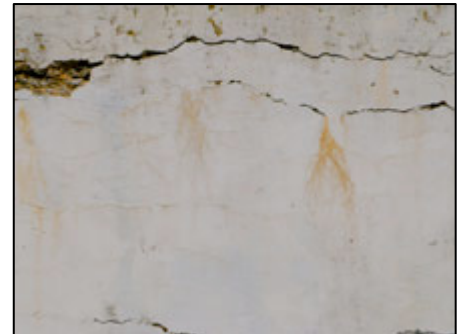
When not properly designed, constructed or maintained, retaining walls fail. The original design of a retaining wall can be deficient if it does not incorporate an appropriate drainage system behind the wall. Failure can also result from overloading due to unanticipated loads. Overloading often occurs when loads such as other structures, trees, vehicles, or additional fill soils are placed atop the retained side of the wall. Deterioration of a wall can result from either deterioration of wood components or corrosion of steel components. Wood components in retaining walls deteriorate and lose structural capacity as they are exposed to long-term wetting and drying. Steel components, including embedded reinforcement, steel sheet piles, and steel tie-back anchors will experience corrosion and loss of cross-section over time due to environmental conditions.

Failure of a retaining wall is typically manifested within the wall by leaning of the wall, pulling through of the tie-back anchors, and/or depressions within the soil on the retained side of the wall. If left unchecked, the failure of a retaining wall that is part of or connected to a structure will result in vertical and lateral displacement of the structure not to mention loss of bearing and ensuing cosmetic damages. If a retaining wall evidences any of these conditions and is suspected of failing, it is recommended that a structural engineer be consulted to identify the condition causing the failure and recommend the appropriate repair measures.
